Item 15 Garage inspection

Cotton Tree Garage Assessment

Main Garage Site

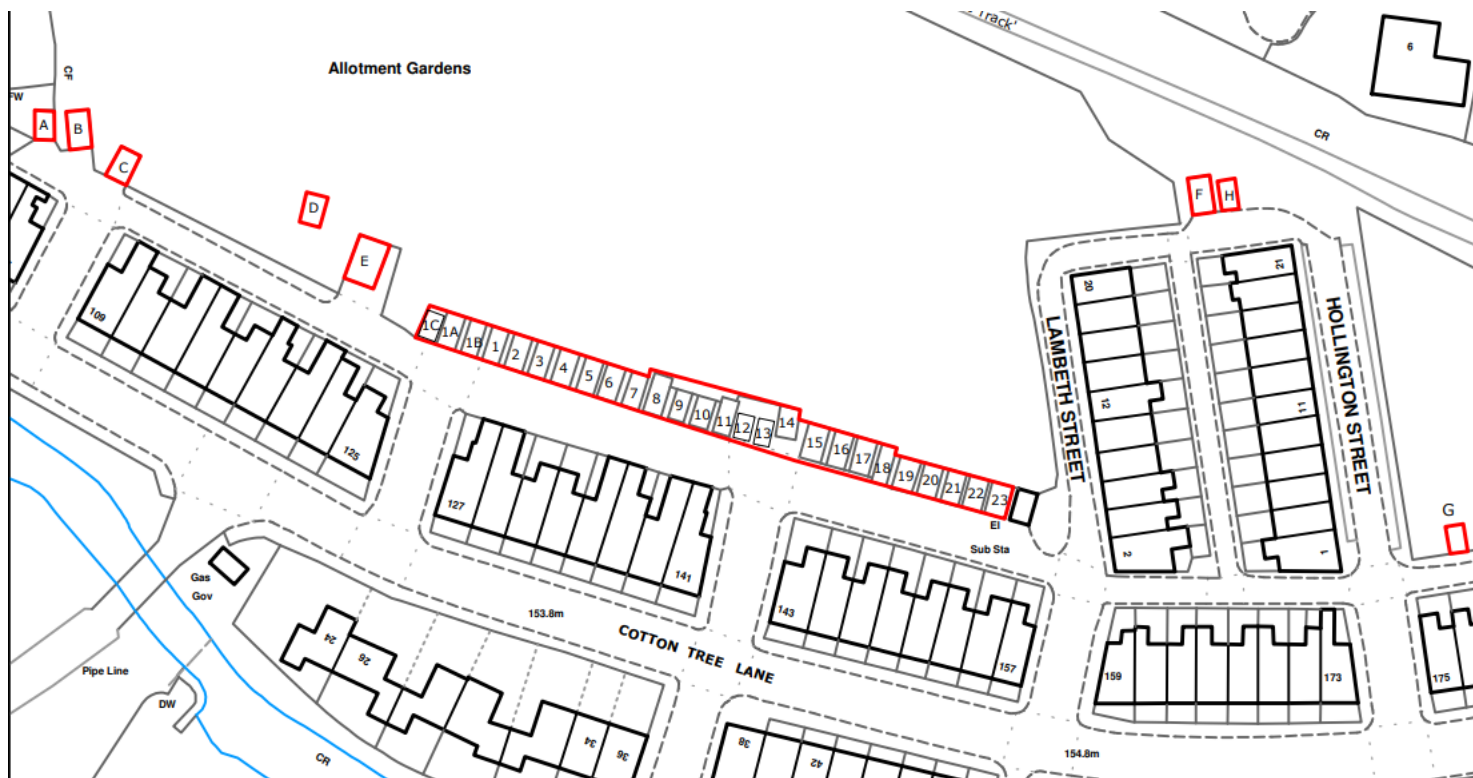
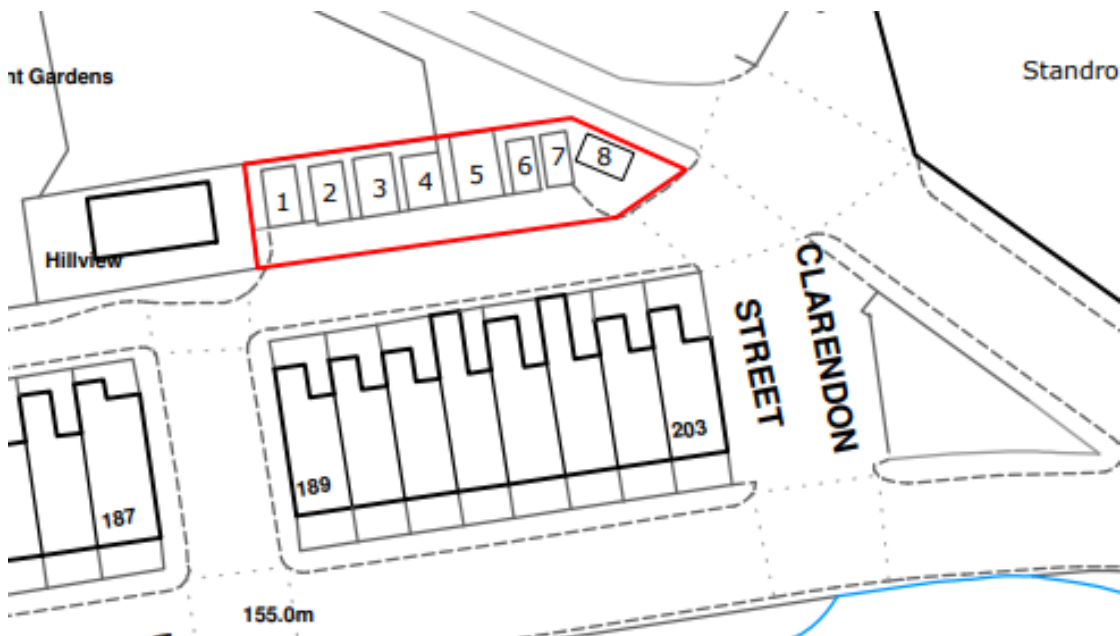
Any comments about road surface? ___ The road is in a poor condition on the corner near to garage 'C'. See photos below.
