Lakeside Cafe, Ball Grove

Building Report Observations

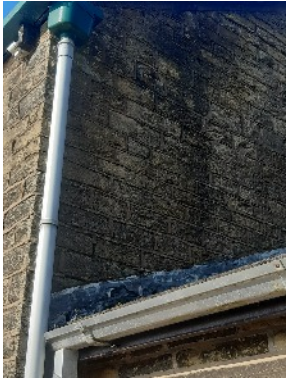
Pointing on wall above lead flashing damaged and missing

This area is directly over the damp affected room

I recommend that the area be re pointed

Lead flashing should be checked and sealed if required

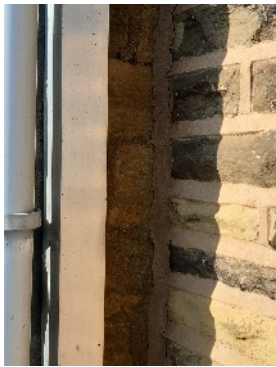
Ponting in corner behind drainpipe is loose and allowing water to get behind to penetrate

I recommend that the pointing be re done

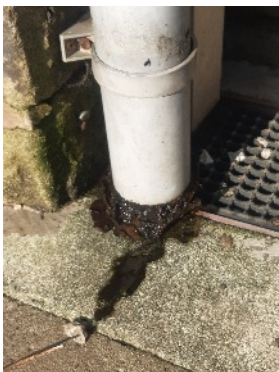
Drain pipe has dropped to floor. Not allowing leaves etc to escape and Making water back up to leak out at top and in mid joint area

Drainpipe should be re fixed in correct position.
Drainpipe should be cleared from top to bottom

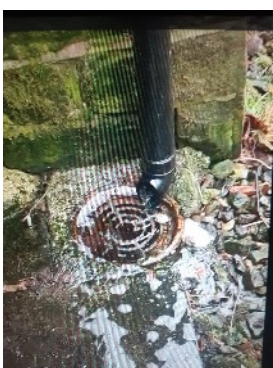
Not relative to the damp area but this drain appears to be blocked

Should be cleaned and cleared
