Item 11L

Ball Grove

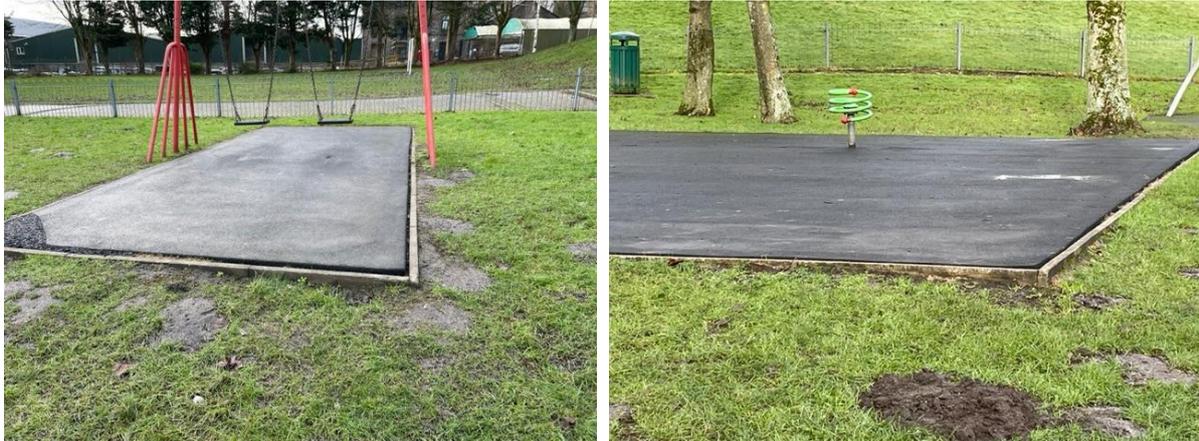
Whilst at Ball Grove, the Clerk and the officers identified two areas where it would benefit but is not a mandatory requirement to fill the area in front of the right-hand side corner of the swings and the corner of the smaller climbing frame area. These can be done in spring as they are very low risk.

There is some shrinking of the safety surfacing but this is well within tolerance and does not need any urgent remedial works. It is something that the contractor of the weekly inspections will monitor and raise if and when it becomes more of a risk.

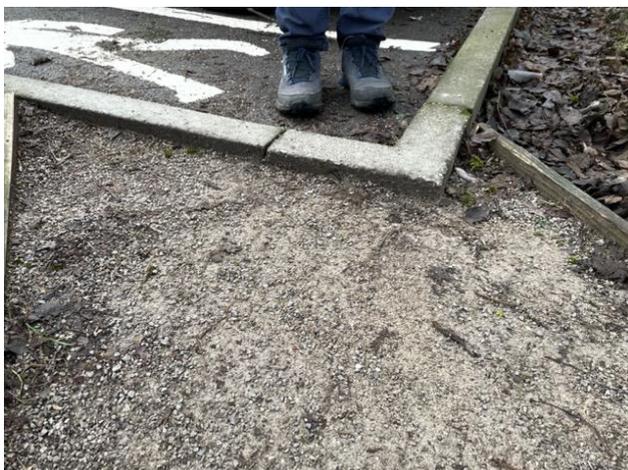
Whilst we were there, I asked that the officers take a look at the path from the corner of the car park onto the road. This is well within tolerance of a step onto a footpath, and they see that, due to the tree roots, it could not be created to finish at road height.

At the car park end of this path, some of the aggregate has settled and would benefit from filling with the stone that is currently cited on the Parish Council's storage area further along the track. This suggestion will be added to the February Parish Council meeting agenda so Councillors can determine whether these works should be carried out.
